Technical Bulletin

NP01	TB0006-2016	Élan Motorsports Technologies	
From:	Robert Lindsey – Project Engineer, NP01		
Subject:	Upright Improvement	Date:	15 Feb 2016

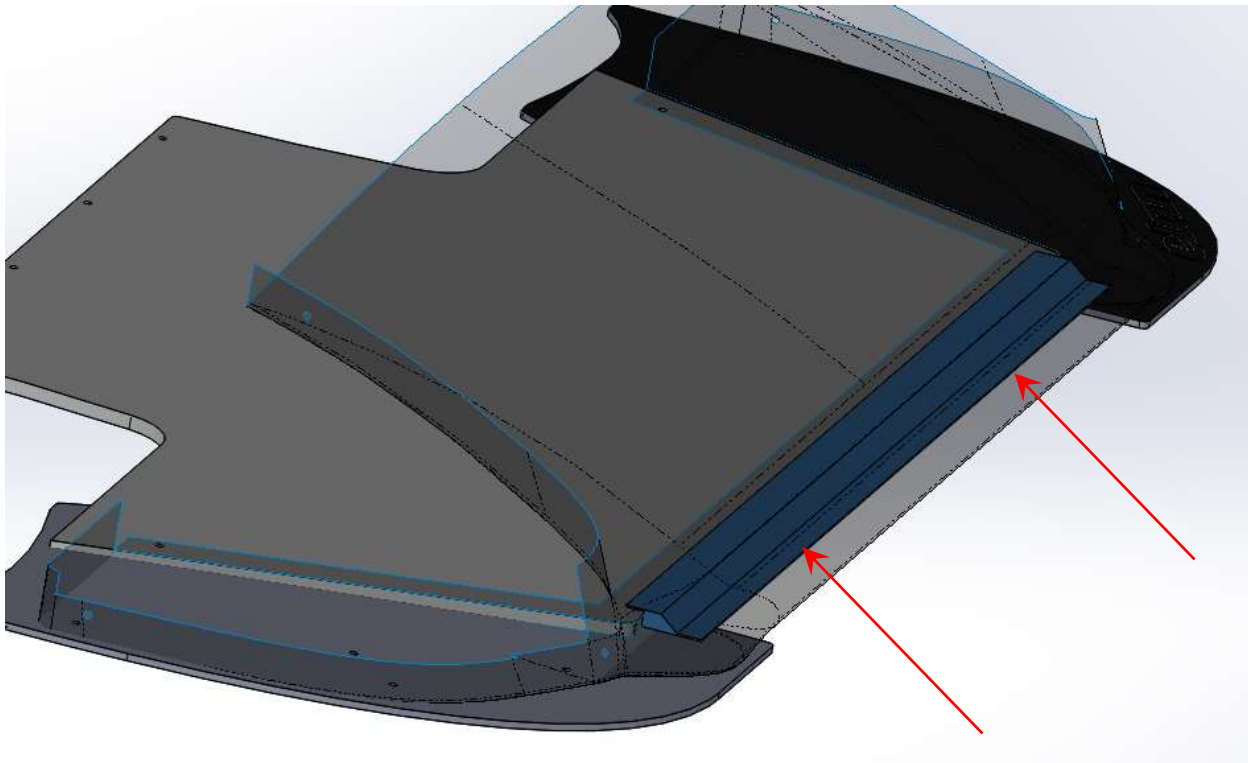
Some customers have experienced fracturing of the splitter at its joint to the “Splitter Base”. To prevent this we have added reinforcement to all parts after chassis #15.

If your splitter lacks the update you will receive a reinforcement strip to be glued into the splitter as shown below.
