Technical Bulletin

DP02	TB0005-2006	Elan Motorsports Technologies	
From:	Christian Rushforth		
Subject:	Fire Bottle Mounting	Date:	November 20 th , 2006

Attention all Elan DP02 2006 teams

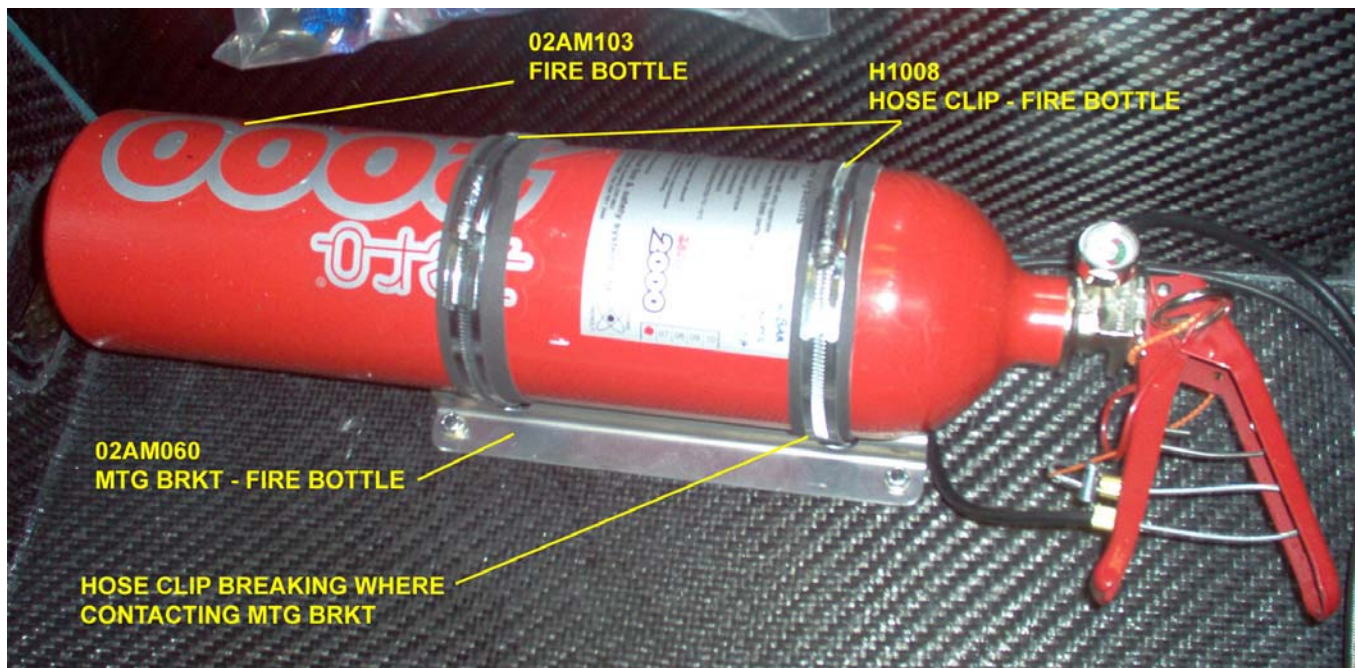
Elan has identified an issue with the fire bottle mounting and hose clip installation on cars #1 through to #15. After some periods of running the hose clips holding the fire bottle to mount may break causing the fire bottle to become detached in-turn leading to loss of extinguishment

It is recommended that all teams modify their fire bottle mounting and clips to the following specification

1. Through holes in fire bottle mounting bracket to be enlarged and made square so that the hose clip does not contact on two points. Current holes are circular in manufacture which aggravates the issue of the band clamp picking up.
2. Line fire bottle mounting bracket and underneath hose clamps with approx. 1/8" thick foam
3. Hose clamps that may come into contact with mounting bracket to have heat shrink material added to them.
4. Do not over-tighten band clamps
